Manhole Inspection Summary

Manhole # S39CC_011MH

Insp Date: **8/31/09 1:03 PM**

Location Address: **818 EAGER ST**

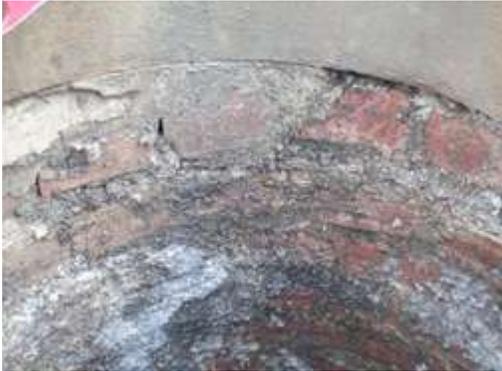
Defect 3

WALL INFILTRATION

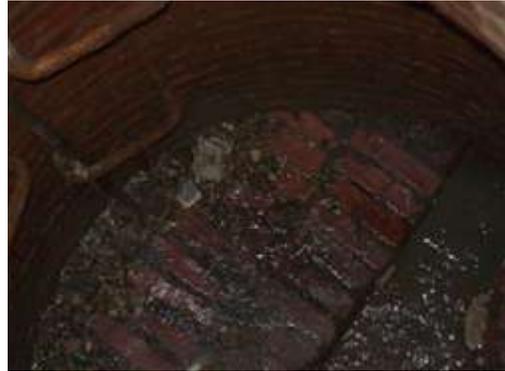
Defect 2

DEBRIS ON BENCH

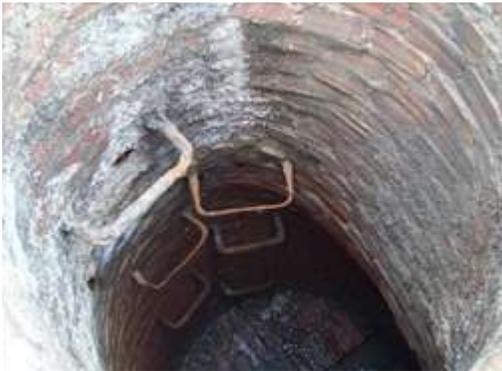
Defect 1

Steps Count: **6** Missing: **1** Corroded

Surcharge Evidence Of Surcharge Depth: **9.5** (ft.) Active Surcharge Present

CORROED STEPS AND SURCHARGE EVIDENCE

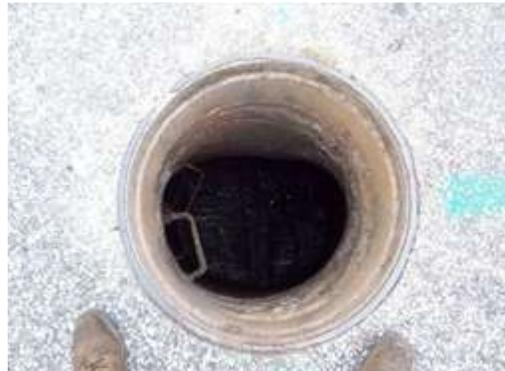
Defect 4

Frame Offset: **1** (in.) Condition: Sound Cracked Leaks

frame offset

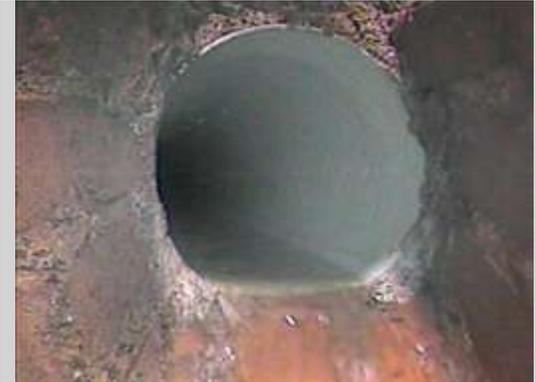
12 O'Clock Outflow

8 in. Circular Gravity Sewer
Pipe Out @ 12 O'Clock

Pipe Height: (in.) Direct
Pipe Material: **Clay** Pipe Lined
Invert Depth: **11.50** (ft.) Flow Characteristics: **Slow**
Deposits: None Mud Sludge Debris Grease
Silt Depth: (in.) Deposits Extent:
Infiltration: **None** Pipe Seal Cond: **Sound**

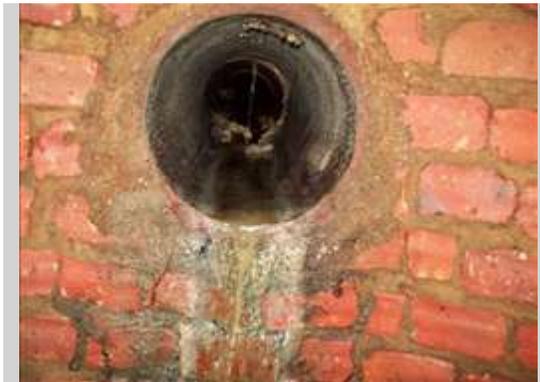
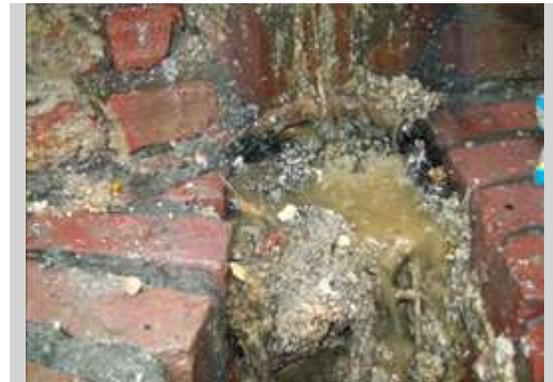
3 O'Clock Inflow

8 in. Circular Gravity Sewer
Pipe In @ 3 O'Clock

Drop In @ 3 O'Clock

Pipe Height: (in.) Direct
Pipe Material: **Clay** Pipe Lined
Invert Depth: **8.30** (ft.) Flow Characteristics: **Slow**
Deposits: None Mud Sludge Debris Grease
Silt Depth: (in.) Deposits Extent:
Infiltration: **None** Pipe Seal Cond: **Sound**

Drop: **Inside** **Direct**
Angled: Reading: (ft.)
Inv Depth: **11.20** (ft.)
Drop Condition: **Clogged**

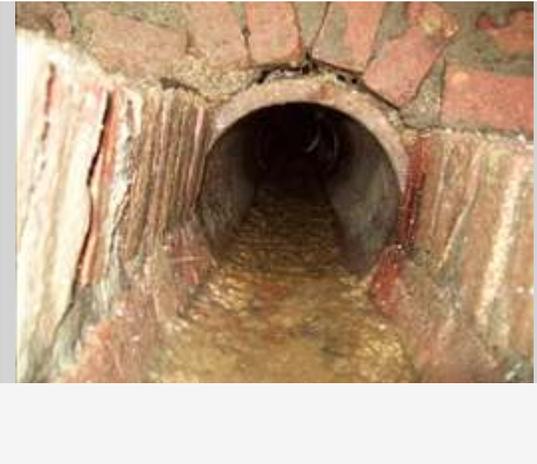
6 O'Clock Inflow

8 in. Circular Gravity Sewer

Pipe In @ 6 O'Clock

Invert Depth: **11.40** (ft.) Flow Characteristics: **Slow**
